Manhole Inspection Summary

Manhole # S09II2020MH

Insp Date: **7/11/06 11:22 AM**

Location Address: **6505 EDENVALE RD**

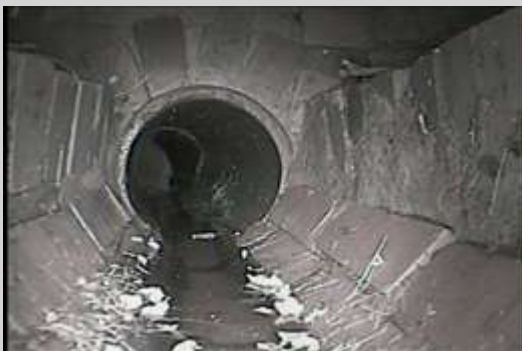
8 in. Circular Gravity Sewer Pipe In @ 6 O'Clock

Comments **The I6 pipe picture shows Channel root intrusion.**

Condition: ☐ Sound ☐ Cracked ☒ **Root Intrusion** ☐ Deteriorated ☐ Leaks ☐ Debris
